# Visual Inspection Anomalies of Fiber Stub Small Form-Factor (SFF)/Small Form-Factor Pluggable (SFP) Assemblies

David Lach, *Senior Engineer*

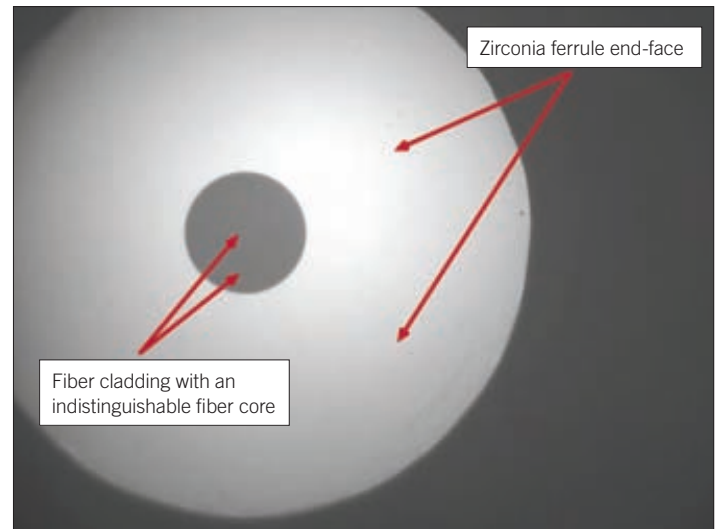
Figure 1.

Figure 1 shows a single fiber (Simplex) connector end-face consisting of a zirconia ferrule and a single optical fiber concentric to the ferrule. This type of end-face configuration is common in many connector types including, but not limited to: Subscriber Connector (SC), Lucent Connector (LC), and other variations of Ultra Physical Contact (UPC) and Angled Physical Contact (APC) connectors. It is also popular as an optical interface within SFF/SFP optical transceiver assemblies that employ fiber stubs as optical interfaces.

There is a good contrast between the ferrule (outer white portion) and fiber (center dark gray portion). Within the fiber itself, there is consistent gray shading. Any artifacts present on the end-face would show up as darker shaded areas, indicating dirt and debris. Artifacts might also appear as much brighter areas, depending on whether a metal has been smeared onto the surface of the end-face. Changes in contrast such as these are used by semi-automatic inspection systems to perform analyses and determine if the end-faces pass programmed criteria for particle count, size and location. These inspection systems are deemed “semi-automatic” because the test instrument’s focus and positioning are manual.

For camera systems to operate, the correct amount of light needs to reflect off the sample surface into the camera. In Figure 1, light is reflecting off the ferrule, causing it to appear bright and white. Light is also reflecting off the fiber, but to a lesser extent, causing it to appear a darker charcoal gray. A good portion of light from the source is actually absorbed by the fiber. Light captured by the fiber inevitably has to be emitted, or absorbed.

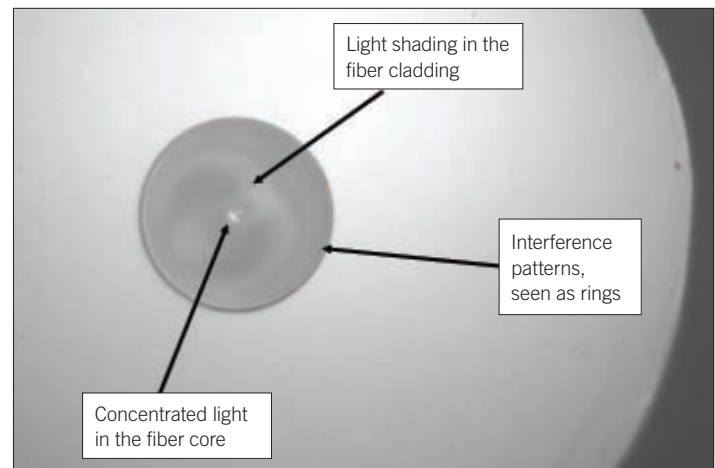
Figure 2.

Figure 2 illustrates the consequences of light being reflected back into a fiber stub off reflective surfaces within a TOSA device. The reflective surfaces may include the TOSA metallic canister, and a lens integral to the canister.

Figure 2 illustrates evidence of back reflection. Rings (interference patterns) are present around the outer circumference of the fiber. Also, lighter areas of shading make the fiber cladding appear visually inconsistent. This phenomenon may create a problem for semi-automated inspection systems.

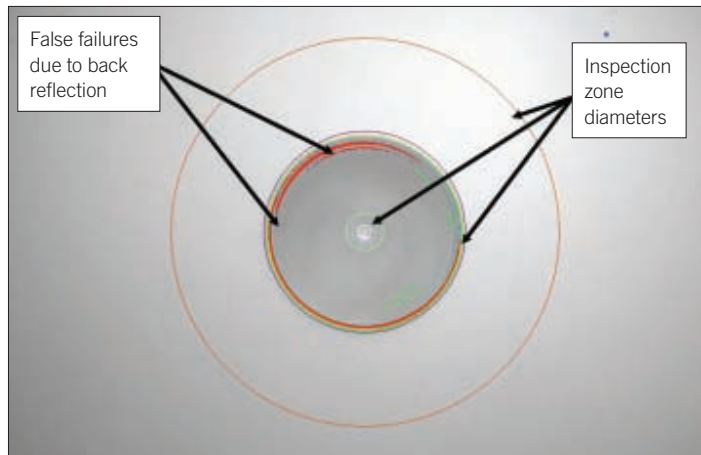
Figure 3 represents an actual inspection result from the end-face captured in Figure 2.

The inspection system has indicated false positives, highlighted in red on Figure 3. The failure sites mimic the interference pattern seen in Figure 2. This end-face is a known good end-face, as it is the same end-face illustrated in Figure 1, which passed inspection. To reproduce this phenomenon, the original TOSA device containing this sample end-face was disassembled. In doing so, a reflective surface could be placed directly behind the emitting end-face (internal end-face) of the TOSA fiber stub. Figure 1 illustrates light emission into free air, and Figure 2 illustrates light reflecting off a reflective surface back onto the fiber stub inner end-face surface.

Current inspection system software may be adjusted to overcome this issue, but at a cost. Inconsistent variables, such as arc length, width, contrast and position, cause a portion of the fiber cladding to be "less inspectable" than other areas where contrast and gray scale shading are consistent. If software is modified to ignore the patterns, it may miss true artifacts, including large edge chips considered to be true failures.

Several possibilities for resolution may be explored. These methods include, but are not limited to, Anti-Reflective (AR) coatings used within TOSA devices or polarization and filtration techniques utilized within inspection equipment. As of now, the false positive issue has been addressed with a software modification. As this modification is only temporary, future advancements in optical interface technologies, including reductions in size, increased optical power handling capabilities, and finer surface finishes, are expected over time. The thoroughness of optical cleanliness inspections will have to follow suit. It is believed that the designers of optical inspection systems should expect more of these types of challenges as optical interface technologies progress.

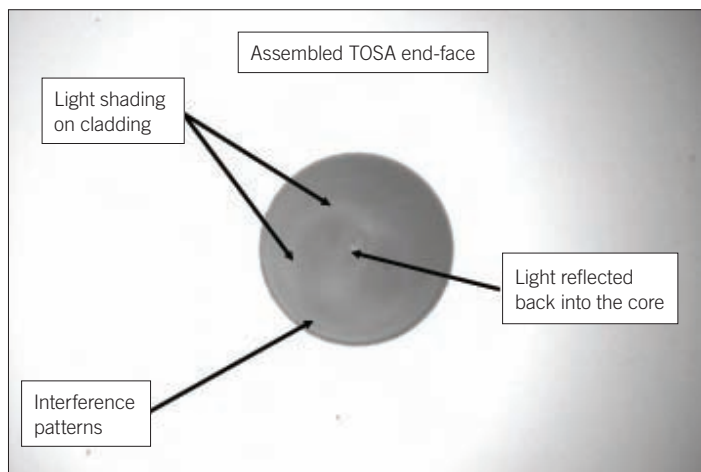
Figure 4.

Figure 4 illustrates an actual picture of an assembled TOSA end-face showing the back reflection phenomenon. The pattern only appears in approximately half of the available circumference, which is believed to be influenced by the angle of polish on the fiber stub inner end-face. The inner end-face angle may be in excess of 10 degrees.
